CURTAINS WITHOUT BORDERS

SURVEY AND TREATMENT PROPOSAL

Location: Town House, New Hampton, NH

Description of Curtain: Grand Drape with Image of the New Hampton Town House

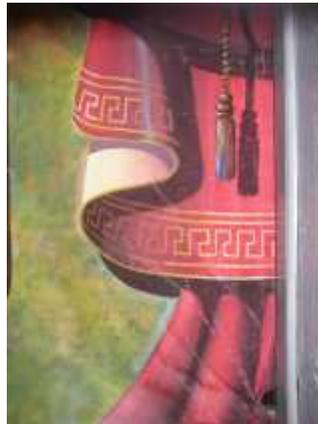
Bottom Edge: secured to bottom metal roller with adhesive. Heavy glue line (construction adhesive) which has become separated from the roller in places

Stains: several old water stains

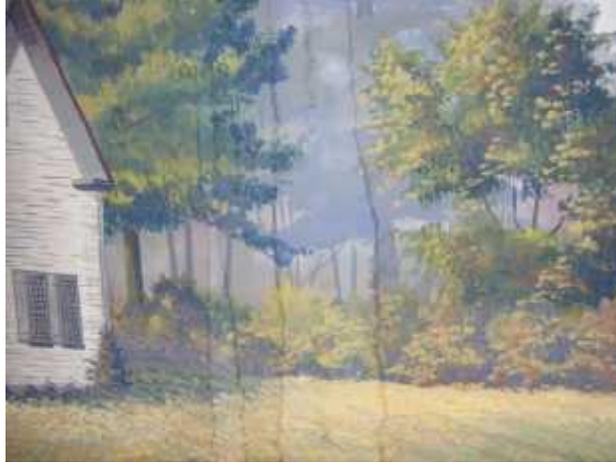
Roller: original galvanized aluminum downspout roller in good condition. Can be reused when padded. It needs to be riveted to improve its strength in the middle

Method of attachment to roller and top support: old animal hide glue along bottom that will need to be reduced. Tacks and nails at the top.

Pulleys and Ropes: the pulleys are very small and are installed on the ceiling. They need to be replaced for safety reasons. The ropes are clothesline that need to be replaced. There is no wall cleat.
