CURTAINS WITHOUT BORDERS

SURVEY AND TREATMENT PROPOSAL

Location: Town House, New Hampton, NH

Description of Curtain: Grand Drape with Image of the New Hampton Town House

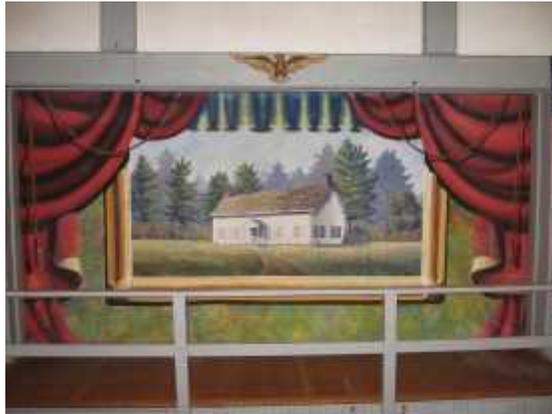
Overall Condition of Curtain: good, with overall dust and minor damage from water stains, creasing and several small tears

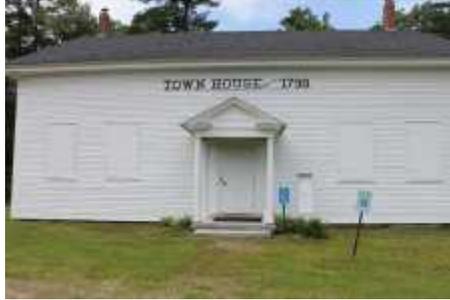
Location: on stage

Iconography: view of the still-used town hall.
